**DEPARTMENT OF TRANSPORTATION****DIVISION OF ENGINEERING SERVICES**

Contract #: 04-0120F4Cty: SF/ALA Rte: 80 PM: 13.2/13.9File #: 69.28**WELDING INSPECTION REPORT****Resident Engineer:**Siegenthaler, Peter**Address:** 333 Burma Road**City:** Oakland, CA 94607**Report No:** WIR-017568**Date Inspected:** 15-Oct-2010**Project Name:** SAS Superstructure**OSM Arrival Time:** 700**Prime Contractor:** American Bridge/Fluor Enterprises, a JV**OSM Departure Time:** 1900**Contractor:** Zhenhua Port Machinery Company, Ltd (ZPMC), Changxing Island **Location:** Shanghai, China**CWI Name:** Qiu Wen**CWI Present:** Yes No**Inspected CWI report:** Yes No N/A**Rod Oven in Use:** Yes No N/A**Electrode to specification:** Yes No N/A**Weld Procedures Followed:** Yes No N/A**Qualified Welders:** Yes No N/A**Verified Joint Fit-up:** Yes No N/A**Approved Drawings:** Yes No N/A**Approved WPS:** Yes No N/A**Delayed / Cancelled:** Yes No N/A**Bridge No:** 34-0006**Component:** TOWER & OBG Components**Summary of Items Observed:**

**BAY#10****ORTHOTROPIC BOX GIRDER (OBG) AT BAY#10**

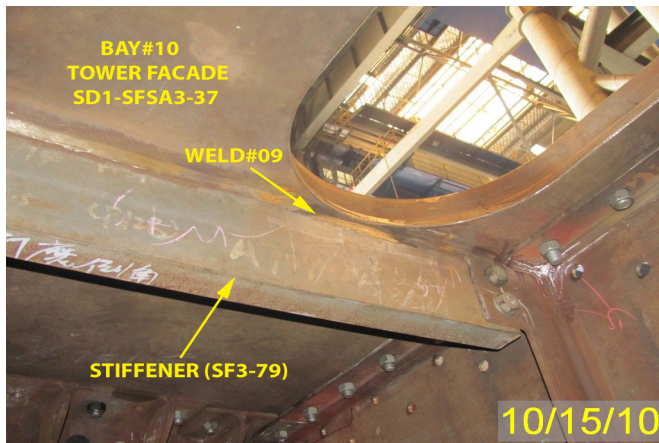
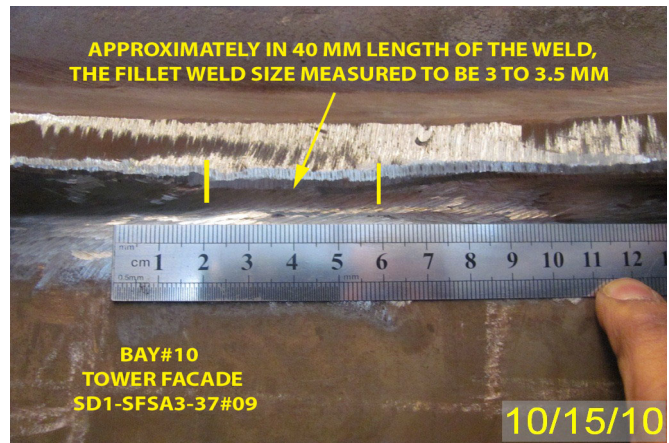
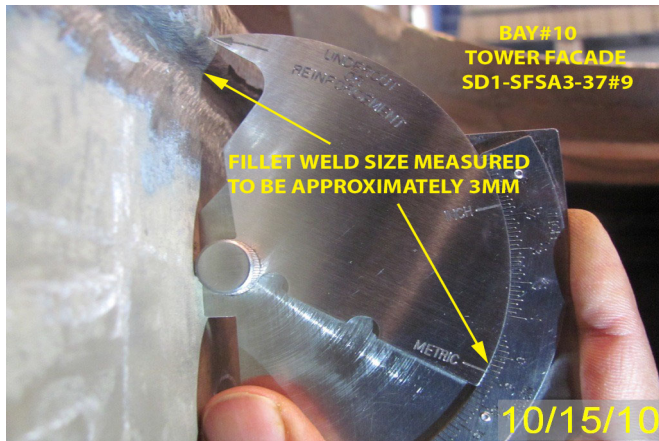
- A single pass fillet weld size on façade measured to be less than the required size as per the approved shop drawing.
- Shop drawing # SD1-SFSA3-37 specifies 6 mm fillet weld size.
- In a total 1335 mm length of the weld, this QA inspector observed that 40 mm length of the weld size ranges from 3 to 3.5 mm.
- This is due to the lack of room/space to do the required size of welding.
- This weld is a fillet weld, joining the facade top plate to the stiffener plate (SF3-79).
- The component and weld designations are identified as SD1-SFSA3-37; Weld#09.

AWD 1.5 2002, Section 6.26.1.7: “ A fillet weld in any single continuous weld may underrun the nominal fillet weld size specified by 2mm[1/16in.] without correction, provided that the undersize portion of the weld does not exceed 10 percent of the length of the weld. On the web-to-flange welds on girders, underrun shall be prohibited at the ends for a length equal to twice the width of the flange”.
